Why We Pulled Our MEMS Vibration Sensor Off The Market

This paper presents the scientific reasons why Instantel concluded that we *could not trust* certain MEMS* (hereinafter referred to as MEMS) vibration sensors for applications in our industry.

Instantel compared vibration measurements from our solenoid-based geophone with those from a MEMS-based accelerometer device. We selected three methods to cover a range of applications commonly found in our industry: drop test, jackhammer, and heavy equipment applications, more specifically:

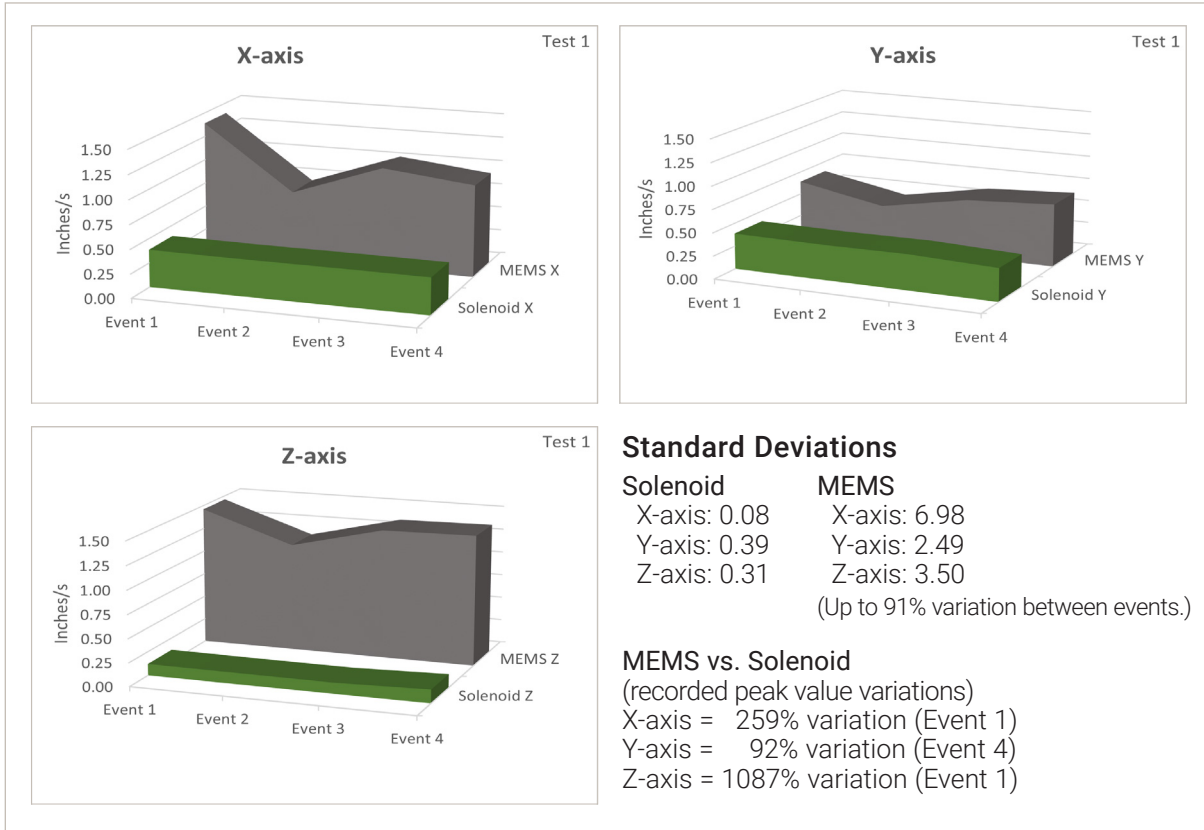
Figure 3. Comparing MEMS versus solenoid peak levels of four weight drops Test 1.

Comparing peak-level data reveals that solenoids and MEMS do not correlate well. The reported dominant frequencies in Table 1. and the four frequency domain plots (Figure 8., Figure 9., Figure 10., Figure 11.) reveals that large vibration rectification error (VRE)* spikes recorded by the MEMS at the 0.5 Hz to 1 Hz range mask the true data as recorded by the solenoid sensor. Due to these VRE spikes the frequency data is lost and unrecoverable by the MEMS vibration sensor.

MEMS data shows extreme variation in peak levels between events where solenoid data remained highly consistent. Relatively low-impact hits caused the MEMS device to report erroneous peak frequencies at 0.5 Hz to 1 Hz.

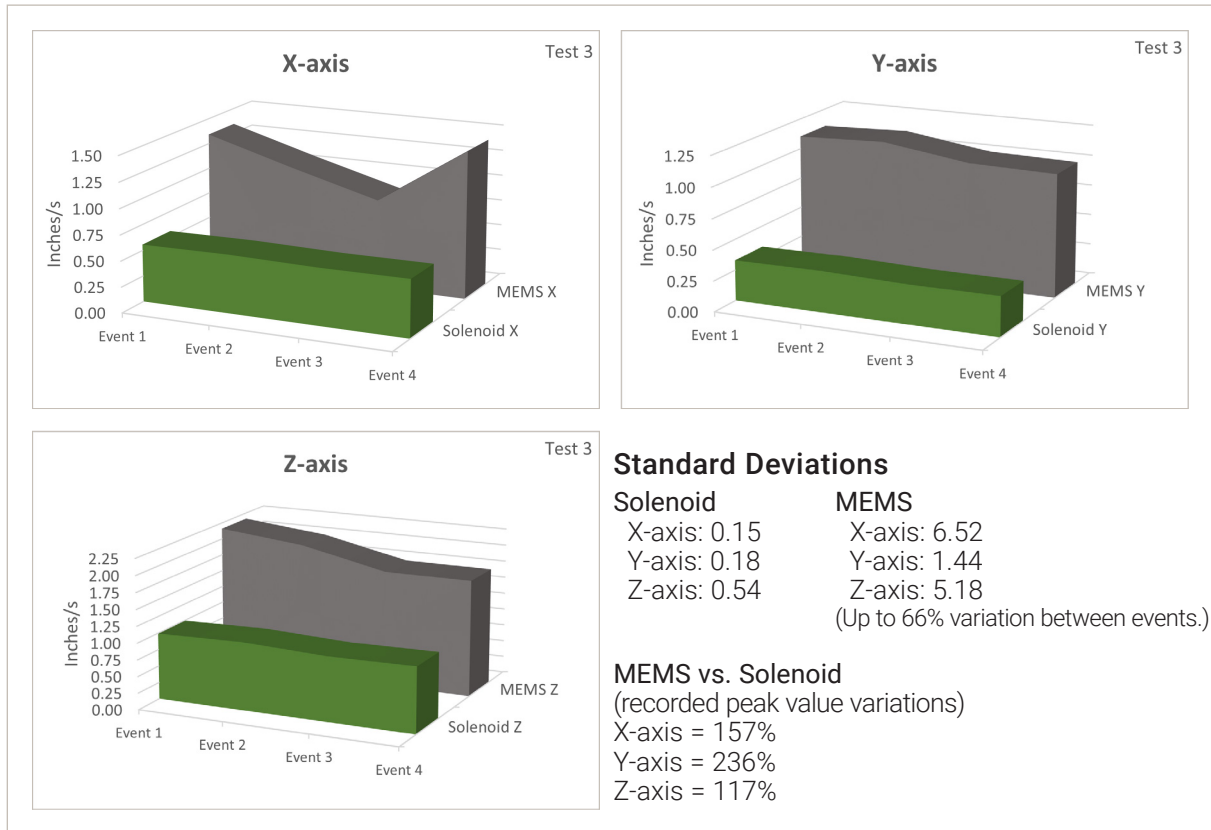
Table 3. Peak levels and dominant frequencies for each controlled weight drop, Test 3.

Figure 17. Comparing solenoid versus MEMS peak levels of four weight drops Test 3.

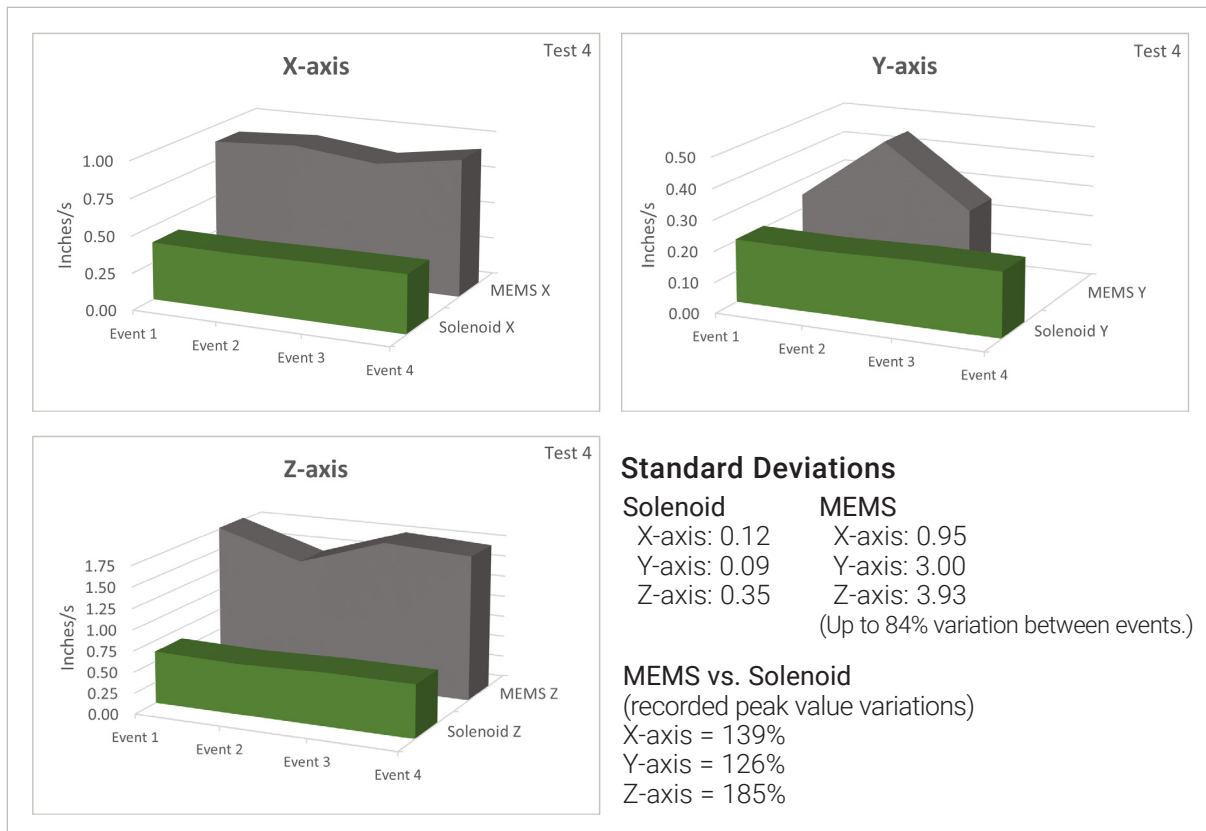
Table 4. Peak levels and dominant frequencies for each controlled weight drop, Test 4.

Figure 18. Comparing solenoid versus MEMS peak levels of four weight drops Test 4.

*The device under test did not report any data for this event on this channel, and the cause for this remains unknown.

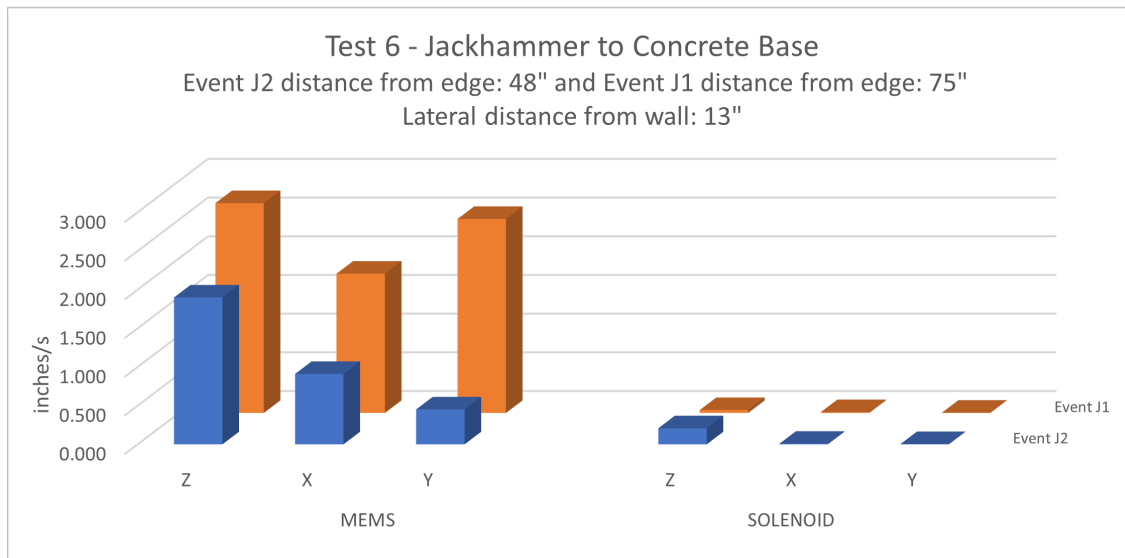
Table 6. Peak levels and dominant frequencies for jackhammer Event J1 and Event J2.

Figure 20. Peak levels of two jackhammer events as recorded by a solenoid device vs. MEMS device.

The MEMS device failed to capture much of the high-frequency content and incorrectly reported peak data at the 1 Hz frequency. The reported levels were much higher than the actual event. This is due to vibration rectification error causing the MEMS device to report false data. The continuous nature of the jackhammer means that this error mode occurs very often, with reported peak values much higher throughout the entire measurement time.

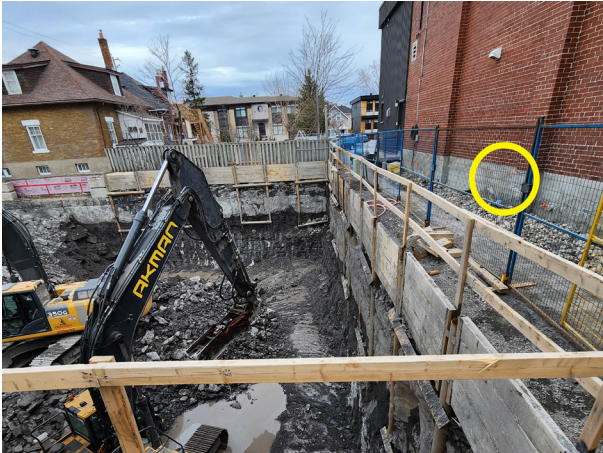
The solenoid and MEMS vibration sensors were installed on an active construction site in Ottawa. A hoe ram was used to fracture the bedrock in order to excavate an underground parking area for a seven-story mid-rise project.

Figure 25. Urban construction site breaking through bedrock.

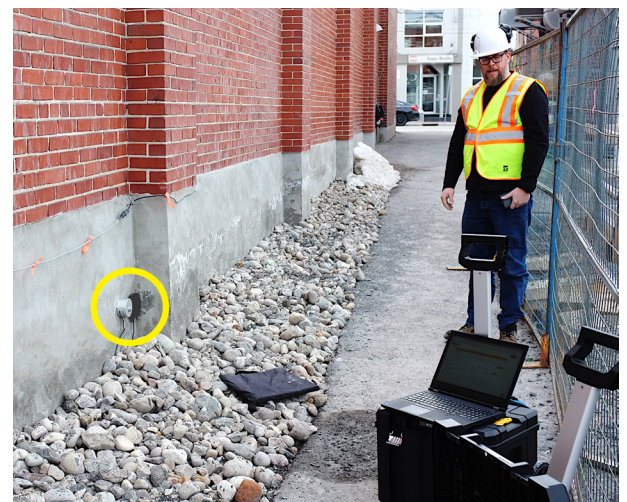
Figure 26. The MEMS and solenoid devices were mounted side-by-side along a concrete wall on an adjacent building to the construction site, 18 inches above the ground.
