# Case Study

## How A Vibration Monitoring System Protects a 100-Year-Old Building During “The One” Skyscraper Project

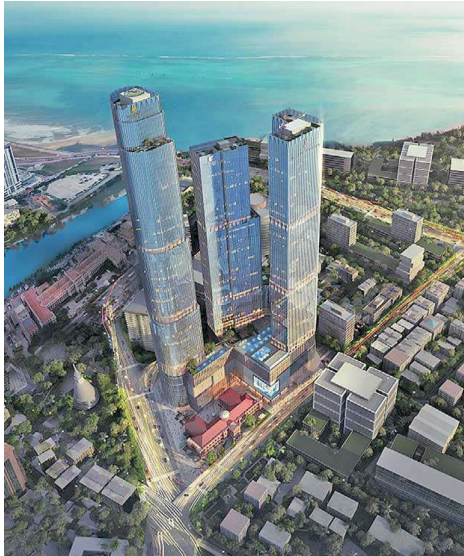
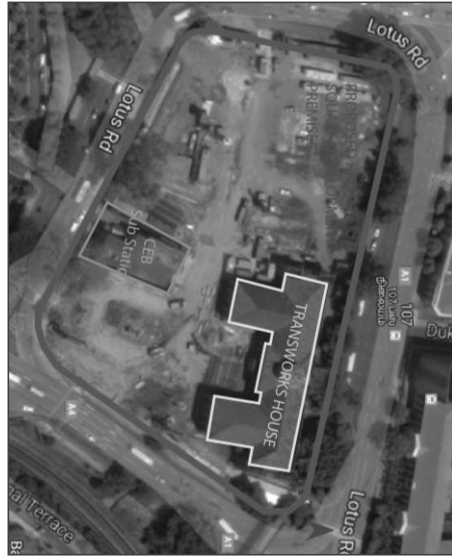
Left: An Urban Architect's Proposed Design Of "The One" Skyscraper Project.  
Right: The Outline Of The Transworks House To Be Preserved During Construction.

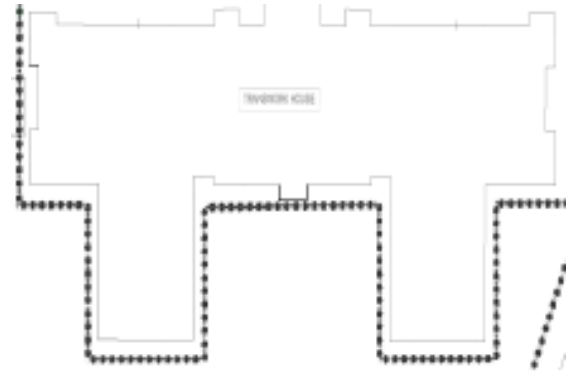
Piling Layout Around the Transworks House

The decision was made to surround the Transworks House using piles to protect it from all construction activities. Although it was generally accepted that the bored piles would not create high vibrations, the secant pile design called for 1 meter of minimum rock socketing. This can create very high vibration levels depending on the depth and rock type.

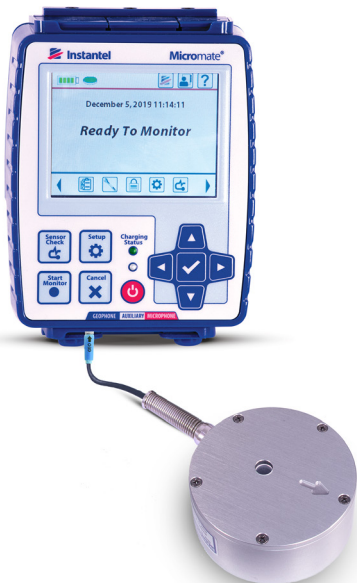
Micromate Seismic Monitor With Geophone

InstanTel's Micromate seismic monitor was chosen to measure ground vibrations according to the Amended Air Blast Over Pressure (ABOP) and Ground Vibration National Standard of Sri Lanka which is based upon the ISO 4866:1990 (and updated to the ISO 4866:2010) Standard. The characteristics of this building fall into Type 4 "Structures declared as archeologically preserved structures because of their sensitivity to vibration".

The Micromate monitoring unit was installed in seven consecutive locations throughout the Transworks House on two levels and one location near the piling machinery. The proximity constraints were very tight, the piles being very close to the foundation.

Option 5 was chosen as it could provide critical information in near real-time. Thus the contractor measured vibration levels with the supervision of an on-site engineer, inside the Transworks House. They repositioned the Micromate geophone to different places and elevations depending on the location of the pile being bored to understand the wave propagation throughout the building. The results were immediately analyzed by the engineer who then determined how much the applied boring pressure needed to be adjusted.
